**Flood Control Project Maintenance
Levee Inspections**

Maintenance Issue Types Only, Levee Inspection Report By Mile - Fall 2015

Sutter Maintenance Yard Maintenance Area 0003

Waterway	Bank	Unit Miles	Inspection Start/End	Inspector
Unit No. 01 Feather River	Right	5.11	11/10/2015 11/10/2015	Keith Millard

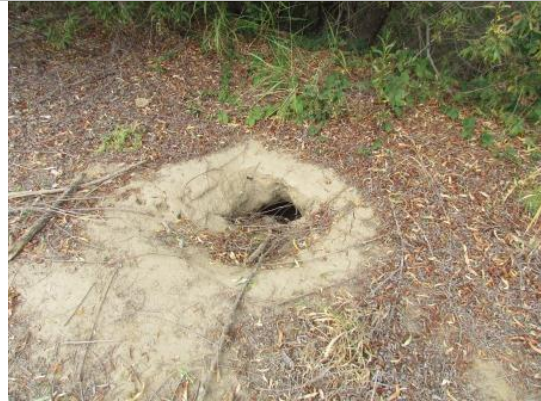
Photo 1 of 2 : FA_2015_MA0003_195_140_20151106_00010.jpg

LM Start	0.78	Rating **	M	Issue No.	140
LM End	0.78	Issue Type +	Ma	Location *	LS
Category	Earthen Levee			GPS Latitude/Longitude	
				Start	End
Item	Animal Control			38.903339 °	38.903339 °
				-121.606209 °	-121.606209 °
DWR ID	DWR_MA0003_01_f_2014_140				
Action/Comments					
No rodents visible, but rodent burrows visible; need to backfill and compact or grout burrows.					
Inspector Comments: There is a rodent hole on the landward toe road approximately 6" in diameter.

This photo was taken from the landward levee slope near the toe road facing north looking at an approximately 6" rodent hole. Fall 2014.

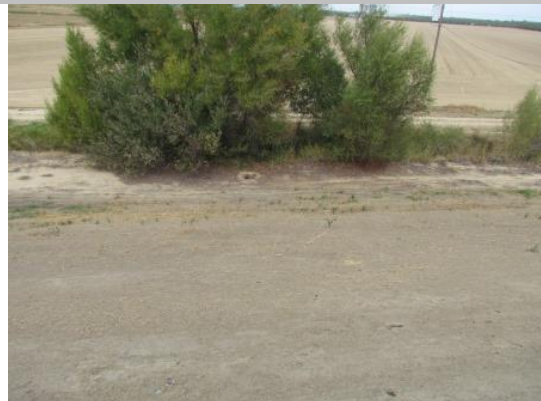
Photo 2 of 2 : FA_2015_MA0003_195_140_20151106_00011.jpg

This is another photo of the rodent hole to show its relationship to to levee toe, toe road, and drainage ditch. Fall 2014.

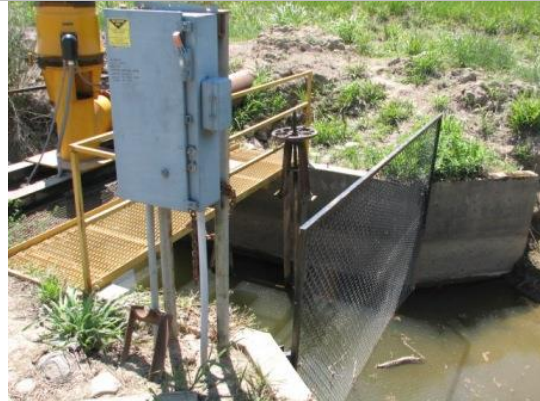
Photo 1 of 1 : FA_2015_MA0003_195_5_20151106_00001.jpg

LM Start	0.80	Rating **	M	Issue No.	5
LM End	0.80	Issue Type +	Ma	Location *	LS
Category	Interior Drainage & Piping Systems			GPS Latitude/Longitude	
				Start	End
Item	Sluice / Slide Gates			38.903291 °	38.903291 °
				-121.605747 °	-121.605747 °
DWR ID	DWR_MA0003_01_s_2012_5				
Action/Comments					
Inspector Comments: This pipe leaked during the high water event of 2010/2011.

Levee mile 0.80, this photo is looking at the landside toe, one of these pipes leaked during the high water event of 2010/2011. A flap gate prevents flow from the waterward side to the landward side of the levee.

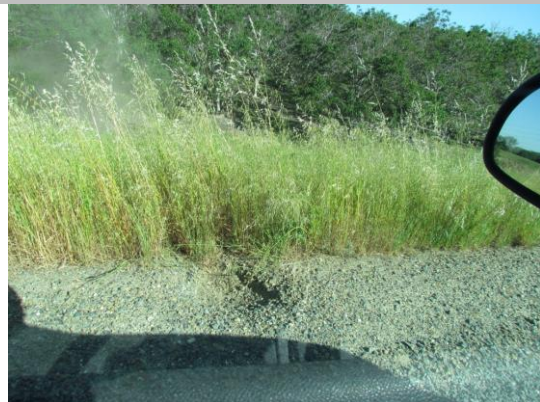
Photo 1 of 1 : FA_2015_MA0003_195_13_20151106_00006.jpg

Photo of a depression in the crown, taken looking at the landside.

LM Start	1.51	Rating **	M	Issue No.	13
LM End	1.51	Issue Type +	Ma	Location *	CR
Category	Earthen Levee			GPS Latitude/Longitude	
				Start	End
Item	Crown Surface / Depressions / Rutting			38.904680 °	38.904680 °
				-121.594229 °	-121.594229 °
DWR ID	DWR_MA0003_01_s_2015_13				
Action/Comments					
Repair depressions or ruts in the crown or slope.

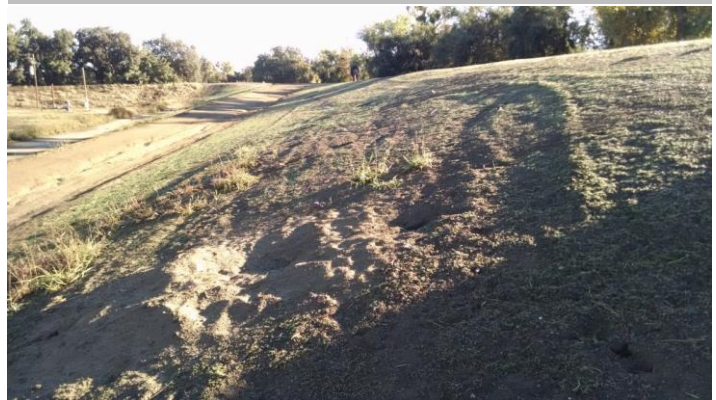
Photo 1 of 1 : FA_2015_MA0003_195_14_20151117_00013.jpg

LM Start	1.77	Rating **	M	Issue No.	14
LM End	1.77	Issue Type +	Ma	Location *	LS
Category	Earthen Levee			GPS Latitude/Longitude	
				Start	End
Item	Animal Control			38.907025 °	38.907025 °
				-121.590375 °	-121.590375 °
DWR ID	DWR_MA0003_01_s_2015_14				
Action/Comments					
No rodents visible, but rodent burrows visible; need to backfill and compact or grout burrows.

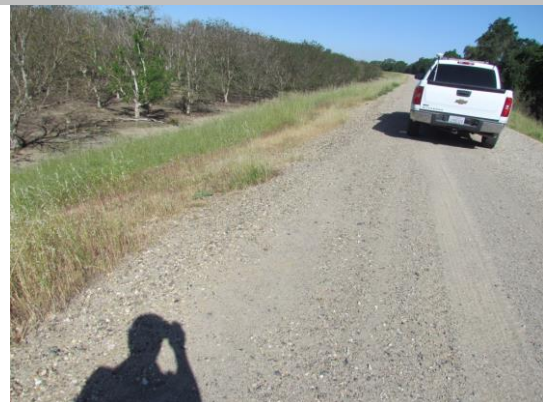
Photo 1 of 1 : FA_2015_MA0003_195_20_20151106_00009.jpg

Photo of slope on the landside facing upstream, areas with little vegetation appear to have eroded leaving the crown smaller.

LM Start	3.20	Rating **	M	Issue No.	20
LM End	3.20	Issue Type +	Ma	Location *	LS
Category	Earthen Levee			GPS Latitude/Longitude	
				Start	End
Item	Slope Stability			38.925909 °	38.925909 °
				-121.585401 °	-121.585401 °
DWR ID	DWR_MA0003_01_s_2015_20				
Action/Comments					
Repair slope instability.

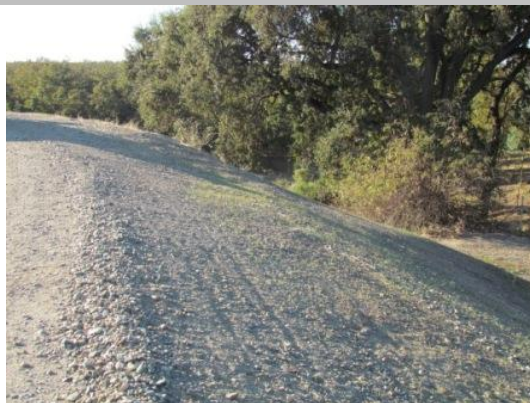
Photo 1 of 1 : FA_2015_MA0003_195_19_20151106_00008.jpg

LM Start	3.59	Rating **	M	Issue No.	19
LM End	3.59	Issue Type +	Ma	Location *	LS
Category	Earthen Levee			GPS Latitude/Longitude	
				Start	End
Item	Vegetation			38.930063 °	38.930063 °
				-121.590211 °	-121.590211 °
DWR ID	DWR_MA0003_01_f_2013_19				
Action/Comments					
Elderberries are blocking visibility and flood fight capability. Inspector Comments: Elderberries on the landward levee toe.

This photo was taken from the levee crown facing south looking down the landward levee slope at a group of Elderberries. Fall 2013.

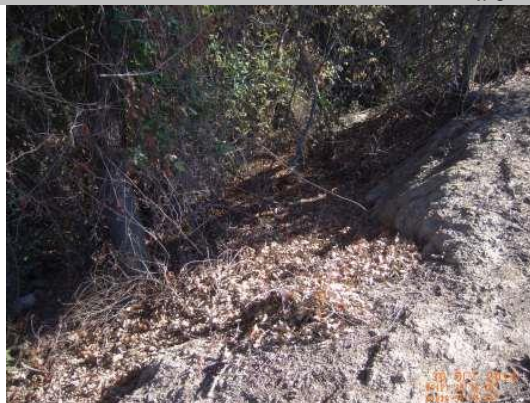
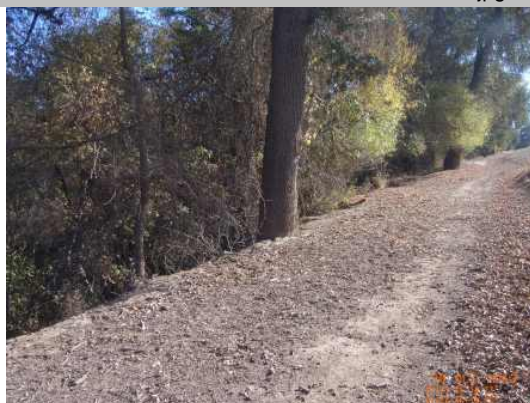
LM Start	4.15	Rating **	M	Issue No.	1
LM End	4.18	Issue Type +	Ma	Location *	WS
Category	Supplemental			GPS Latitude/Longitude	
				Start	End
Item	2015 USACE Erosion Survey, DRAFT			38.937451 °	38.937937 °
				-121.588512 °	-121.588471 °
DWR ID					
Action/Comments					
Inspector Comments: 2013 - Minor toe scour causing gradual erosion of bank slope. Site is within ecological reserve. 2015: Last observed in 2013. [2015 Site ID: FHR_12-3_R]

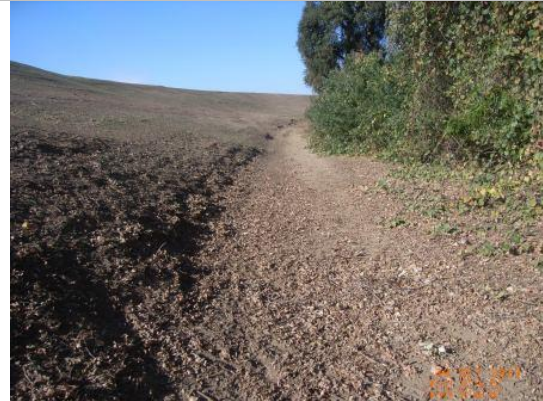
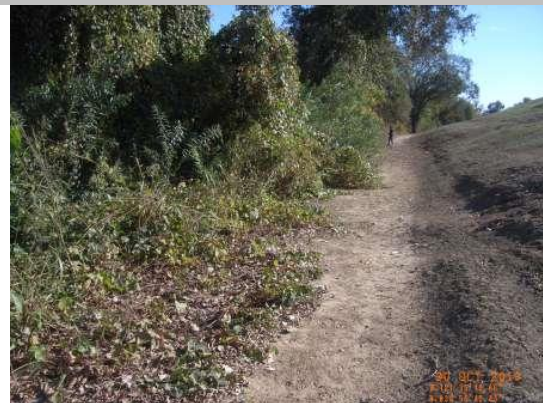
LM Start	4.71	Rating **	M	Issue No.	2
LM End	4.76	Issue Type +	Ma	Location *	WS
Category	Supplemental			GPS Latitude/Longitude	
				Start	End
Item	2015 USACE Erosion Survey, DRAFT			38.945188 °	38.945958
				-121.586096 °	-121.586394
DWR ID					
Action/Comments					
Inspector Comments: 2013 - Minor toe scour causing gradual erosion into the bank slope. 2015: Last observed in 2013. [2015 Site ID: FHR_12-8_R]
